## **PRE-PURCHASE BUILDING & PEST**

### **3A Illawarra Drive, Bowral NSW**

**BA-2026-0930**

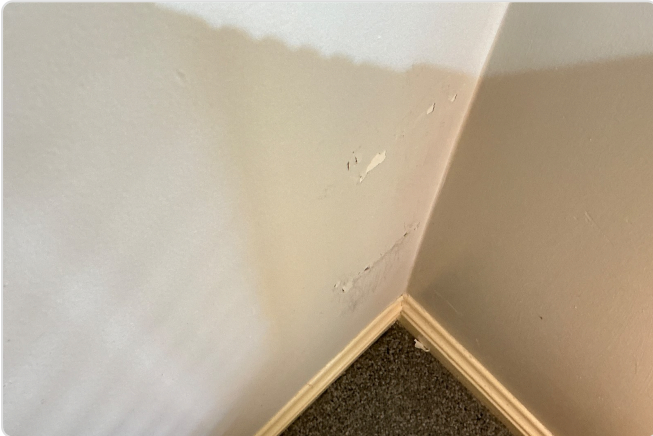
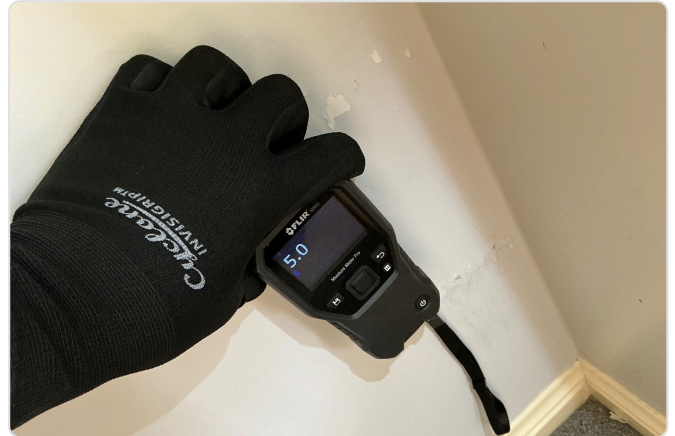
### 1. Paint Finish - Paint Deterioration

| # | Area | Room Type | Location | Defect Name | Recommendation |
|---|---|---|---|---|---|
| 1 | Interior | Living Room | Back wall | Paint Finish - Paint Deterioration | Engage a licensed painter to prepare and repaint the affected surfaces. |

The wall paint finish has deteriorated, flaking and losing its protective function.

**Inspector note:** Moisture reading was checked, and there were no signs of water entry.

**Recommendation:** Engage a licensed painter to prepare and repaint the affected surfaces.

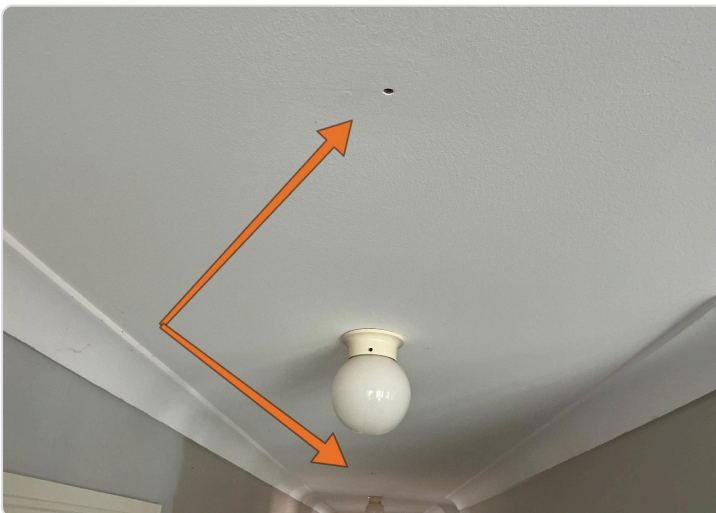
### 2. Plasterboard - Nail Popping

| # | Area | Room Type | Location | Defect Name | Recommendation |
|---|---|---|---|---|---|
| 2 | Interior | Hallway | | Plasterboard - Nail Popping | Engage a plasterer to refix and reset the popped fasteners and patch the surface. |

Nail popping was observed to the ceiling lining where fixings have backed out of the framing.

**Recommendation:** Engage a plasterer to refix and reset the popped fasteners and patch the surface.

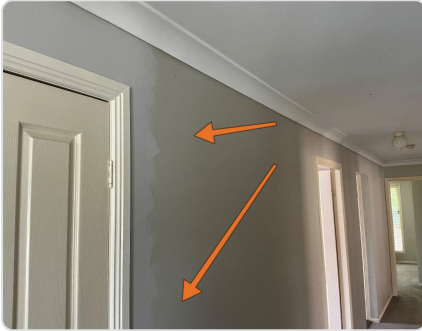
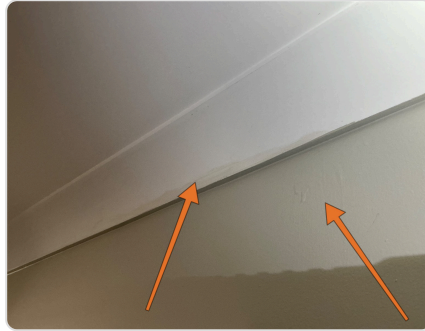
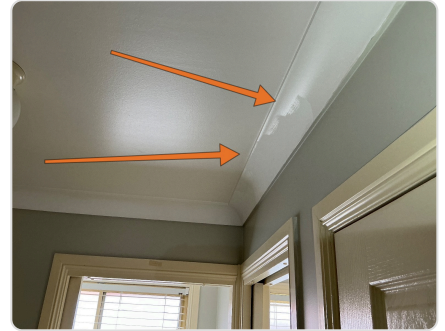
**3. Paint finish - Inconsistent / incomplete****MINOR**

| # | Area | Room Type | Location | Defect Name | Recommendation |
|---|---|---|---|---|---|
| 3 | Interior | Hallway | | Paint finish - Inconsistent / incomplete | Engage a qualified painter. |

Paint finish looks inconsistent or not complete.

**Recommendation:** Engage a qualified painter.

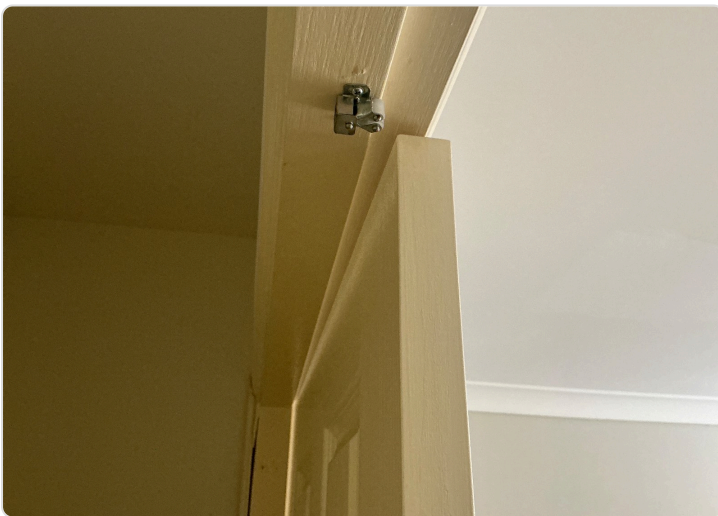
**4. Door - Missing Catcher / Magnet****MINOR**

| # | Area | Room Type | Location | Defect Name | Recommendation |
|---|---|---|---|---|---|
| 4 | Interior | Bedroom 1 | First on the right-hand side from the entry | Door - Missing Catcher / Magnet | Engage a qualified carpenter to install. |

Door is missing a door catcher or magnet hardware.

**Recommendation:** Engage a qualified carpenter to install.**Inspector note:** One is there, and one is missing.

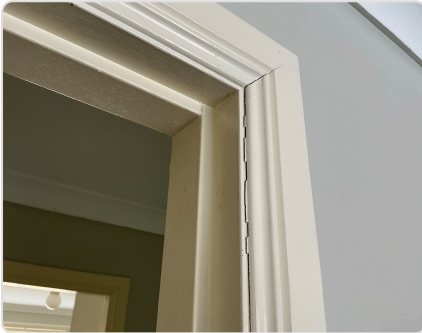
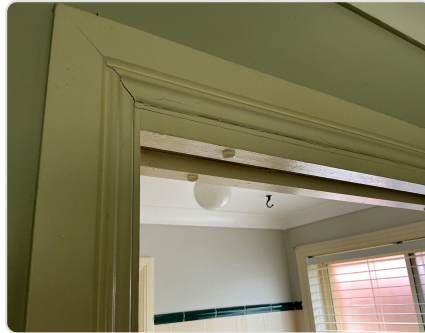
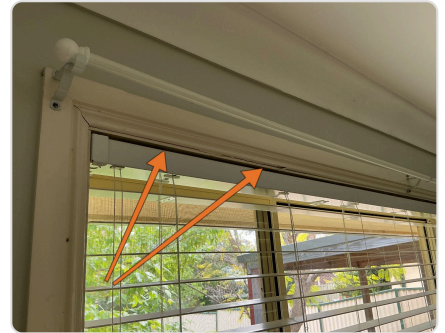
### 5. Door - Architrave cracking

| # | Area | Room Type | Location | Defect Name | Recommendation |
|---|---|---|---|---|---|
| 5 | Interior | Study / Office 1 | | Door - Architrave cracking | Engage a qualified carpenter and painter to repair |

The door architrave is cracking. Needs caulking and a repaint.

**Inspector note:** This was observed on a few other doors internally. Nothing major. It's common for this age of a building.

**Recommendation:** Engage a qualified carpenter and painter to repair

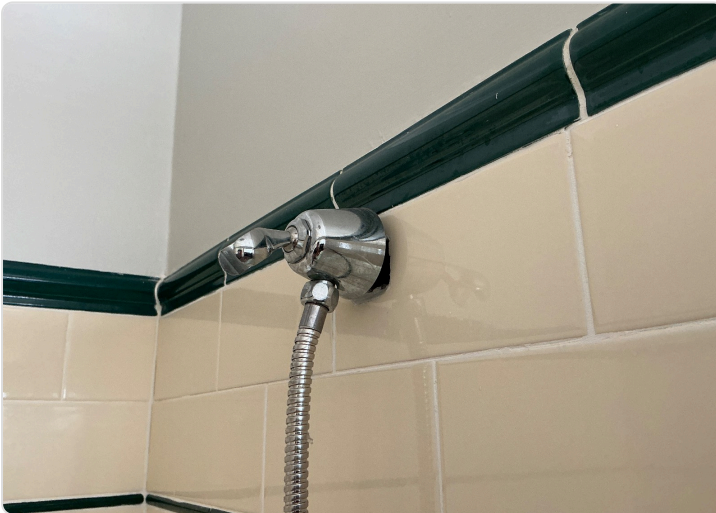
### 6. Shower Head - inadequately sealed

| # | Area | Room Type | Location | Defect Name | Recommendation |
|---|---|---|---|---|---|
| 6 | Interior | Ensuite | | Shower Head - inadequately sealed | Engage a qualified plumber to replace or repair |

A visible gap was noted around the shower head fixture penetration through the tiled wall.

**Recommendation:** Engage a qualified plumber to replace or repair

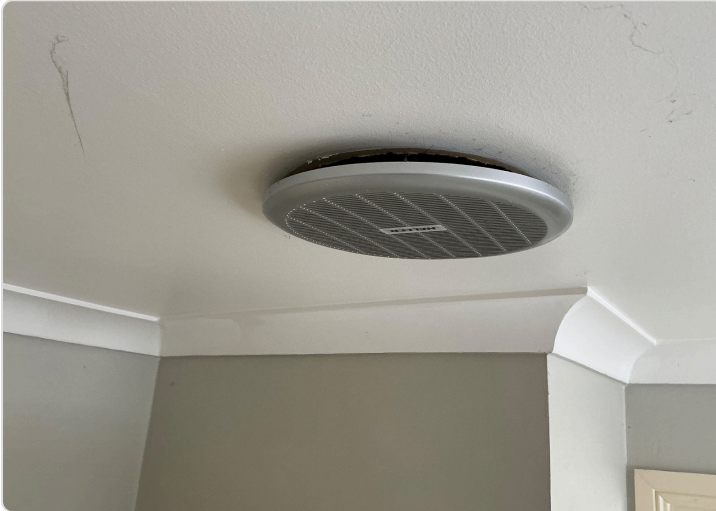
**7. Exhaust fan - inadequately fixed.****MINOR**

| # | Area | Room Type | Location | Defect Name | Recommendation |
|---|---|---|---|---|---|
| 7 | Interior | Ensuite | | Exhaust fan - inadequately fixed. | Engage a qualified electrician. |

the exhaust fan seems inadequately fixed and might require additional fixings.

**Recommendation:** Engage a qualified electrician.

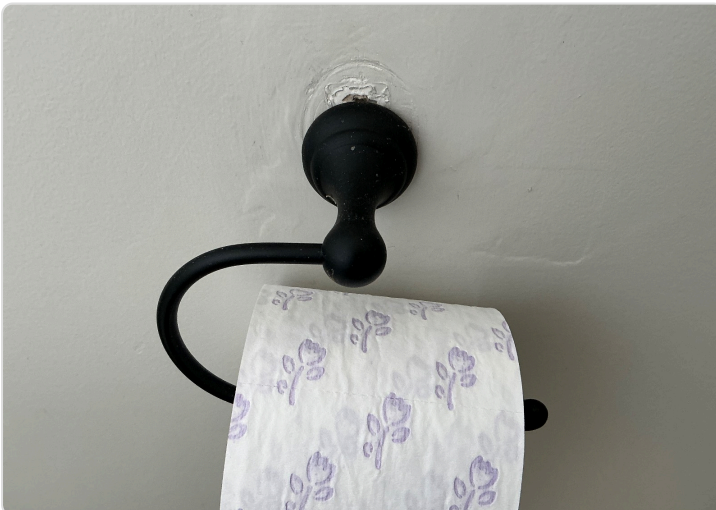
**8. Toilet paper holder - inadequately fixed****MINOR**

| # | Area | Room Type | Location | Defect Name | Recommendation |
|---|---|---|---|---|---|
| 8 | Interior | Toilet | | Toilet paper holder - inadequately fixed | Engage a qualified carpenter to reinstall. |

Toilet paper holder seems to be loose and inadequately fixed.

**Recommendation:** Engage a qualified carpenter to reinstall.

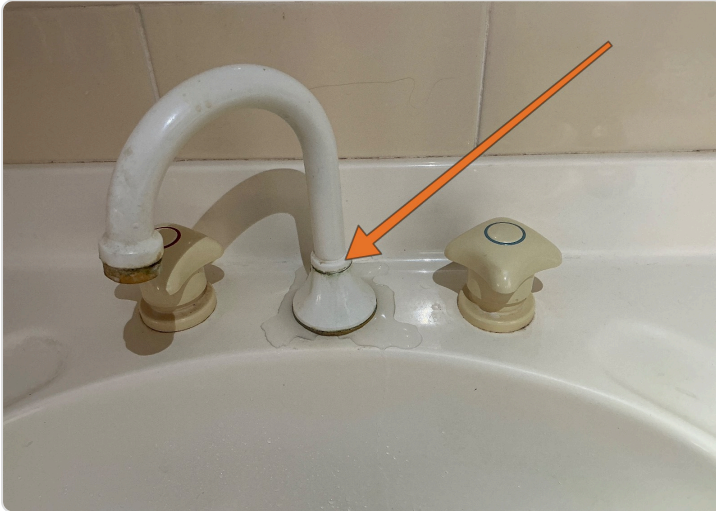
### 9. Tapware - Leaking Tap Head

| # | Area | Room Type | Location | Defect Name | Recommendation |
|---|---|---|---|---|---|
| 9 | Interior | Master Ensuite | Main vanity | Tapware - Leaking Tap Head | Engage a plumber to repair or replace the leaking tap head. |

Water is leaking from the tap head.

**Recommendation:** Engage a plumber to repair or replace the leaking tap head.

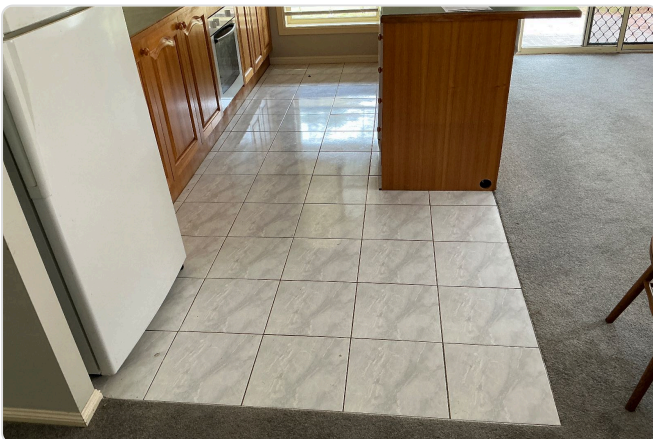
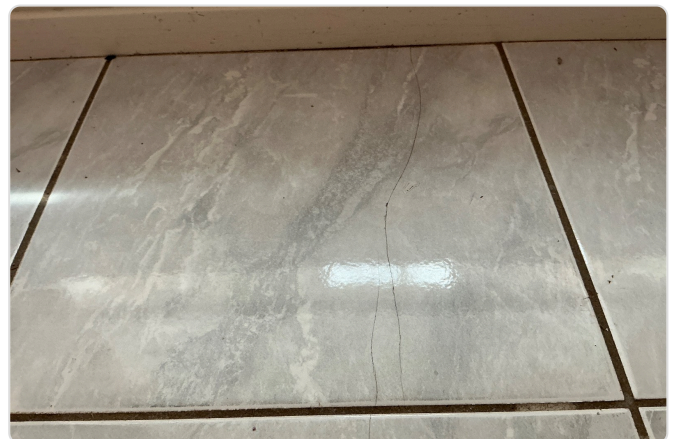
### 10. Ceramic Tiles - Drummy Tiles

| # | Area | Room Type | Location | Defect Name | Recommendation |
|---|---|---|---|---|---|
| 10 | Interior | Kitchen | | Ceramic Tiles - Drummy Tiles | Engage a tiler to remove and re-lay the drummy tiles to restore adhesion. |

The tiles sound drummy and have lost adhesion from the substrate, which can lead to breakage and water penetration.

*Inspector note: Typical for this age of a building*

**Recommendation:** Engage a tiler to remove and re-lay the drummy tiles to restore adhesion.

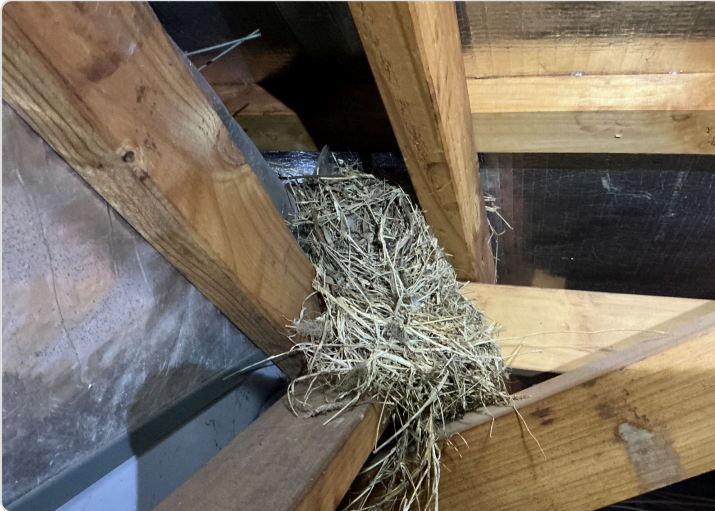
**11. Bird's nest****MINOR**

| # | Area | Room Type | Location | Defect Name | Recommendation |
|---|---|---|---|---|---|
| 11 | Roof Void | | | Bird's nest | Recommend removal and sealing of the entry point where appropriate. |

Bird Nest Present: Bird nesting observed within the roof space.

**Recommendation:** Recommend removal and sealing of the entry point where appropriate.

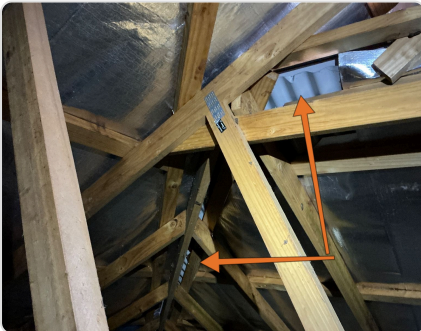
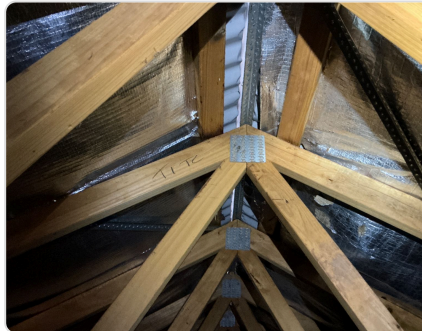
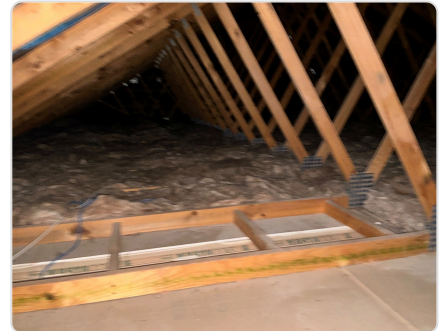
**12. Roof Sarking - Missing on sections****OBSERVATION**

| # | Area | Room Type | Location | Defect Name | Recommendation |
|---|---|---|---|---|---|
| 12 | Roof Void | | | Roof Sarking - Missing on sections | Monitor for condensation and wind driven rain. |

Roof sarking is not overlapped over hips &amp; ridges and missing on some sections, typical on older homes.

**Recommendation:** Monitor for condensation and wind driven rain.

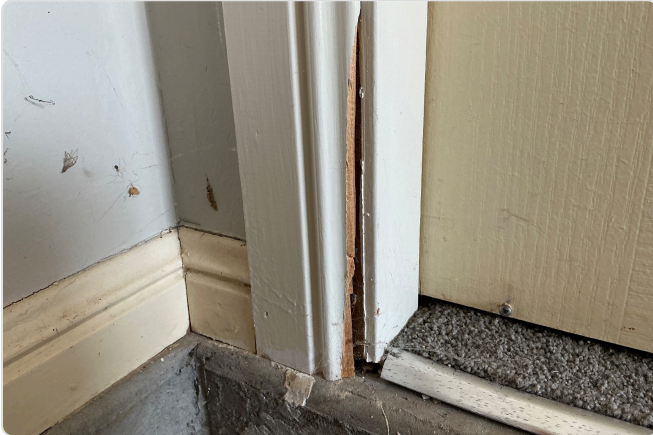
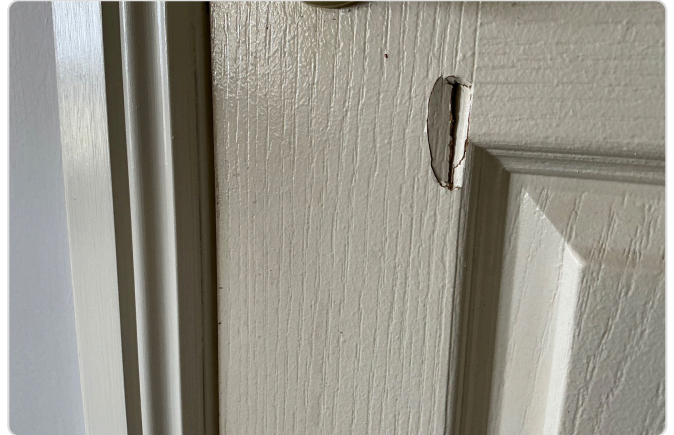
### 13. Door - Impact Damage

| # | Area | Room Type | Location | Defect Name | Recommendation |
|---|---|---|---|---|---|
| 13 | Interior | Garage | | Door - Impact Damage | Repair or replace the damaged door or architrave as required. |

Impact damage was observed to the door or architrave at garage door

**Recommendation:** Repair or replace the damaged door or architrave as required.

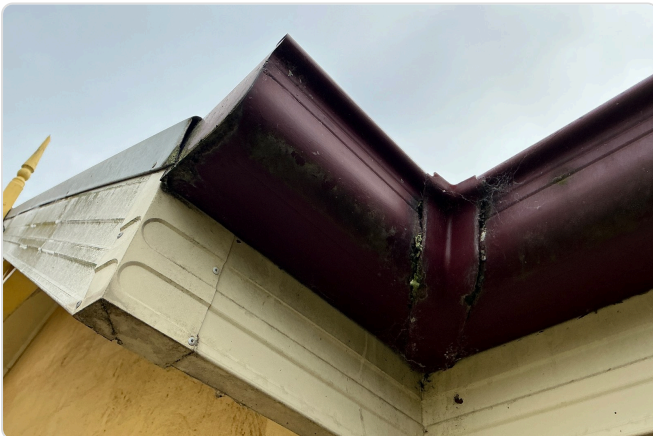
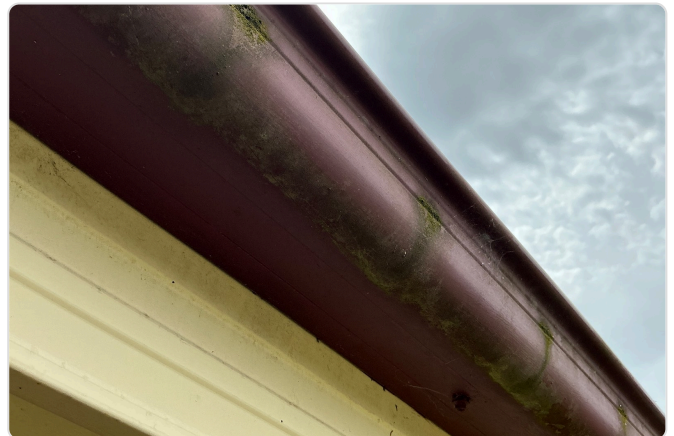
### 14. Gutter - Surface Rust

| # | Area | Room Type | Location | Defect Name | Recommendation |
|---|---|---|---|---|---|
| 14 | Roof Exterior | | Gutters | Gutter - Surface Rust | Engage a roof plumber to treat and seal the surface rust before it penetrates. |

Surface rust was observed to sections of the guttering where the rust is yet to penetrate.

**Recommendation:** Engage a roof plumber to treat and seal the surface rust before it penetrates.

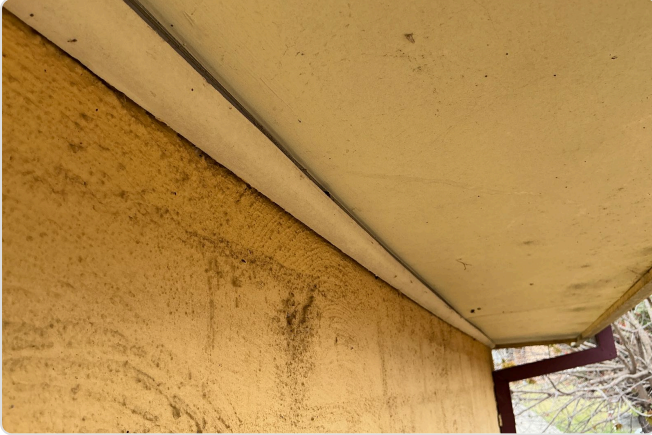
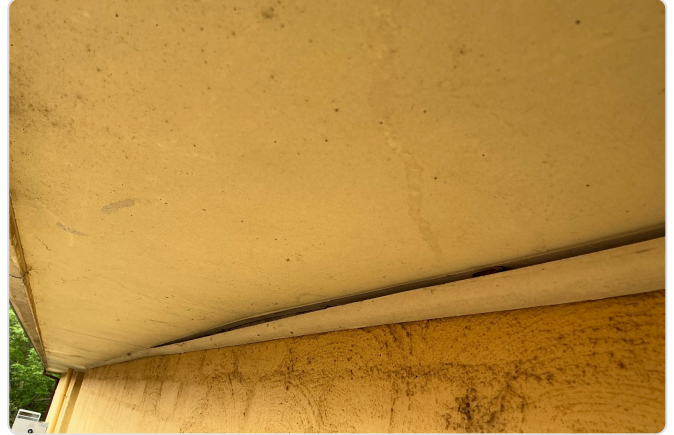
**15. Eaves - Lining Detached****MINOR**

| # | Area | Room Type | Location | Defect Name | Recommendation |
|---|---|---|---|---|---|
| 15 | Exterior | | Eaves | Eaves - Lining Detached | Engage a carpenter to refix the detached eaves lining. |

Sections of the eaves lining have detached.

**Recommendation:** Engage a carpenter to refix the detached eaves lining.

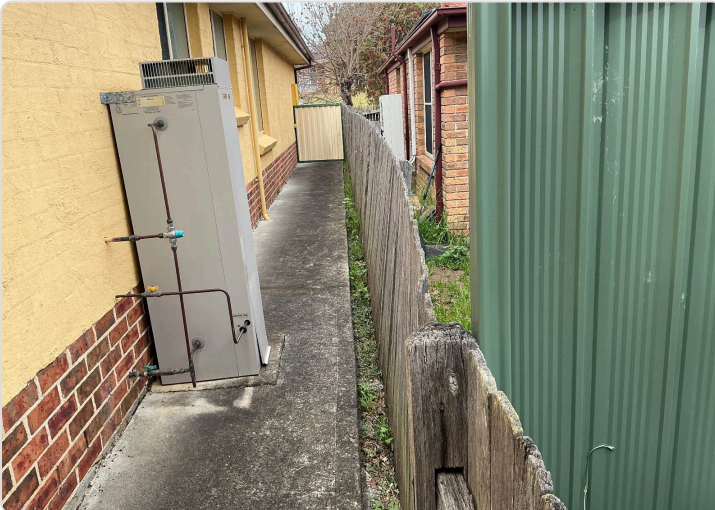
**16. Fencing - Structural Instability****MAJOR**

| <b>Fencing</b> | Timber paling — <b>Requires Attention</b> — See the Defects section of this report for details.<br><i>The fencing requires attention. Refer to the Defects section of this report for details and recommendations.</i> |

| # | Area | Room Type | Location | Defect Name | Recommendation |
|---|---|---|---|---|---|
| 16 | Exterior | | Fence | Fencing - Structural Instability | Re-support, re-plumb or replace the affected sections to make the fencing stable. |

The fencing is leaning and structurally unstable.

**Recommendation:** Re-support, re-plumb or replace the affected sections to make the fencing stable.

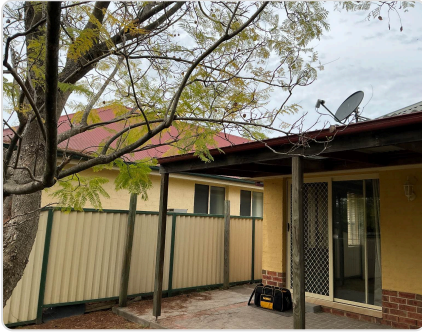
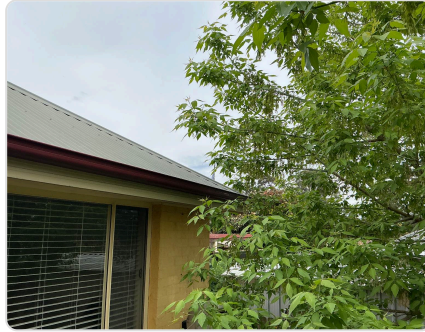
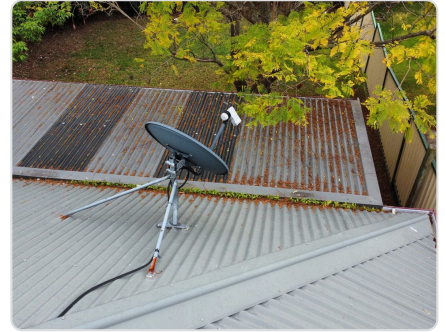
### 17. Tree Overhang - Roof Overhang

| # | Area | Room Type | Location | Defect Name | Recommendation |
|---|---|---|---|---|---|
| 17 | Exterior | Patio | | Tree Overhang - Roof Overhang | Engage an arborist or gardener to cut back the overhanging branches. |

Trees overhang the roof, which can damage the roof covering and block guttering.

**Recommendation:** Engage an arborist or gardener to cut back the overhanging branches.

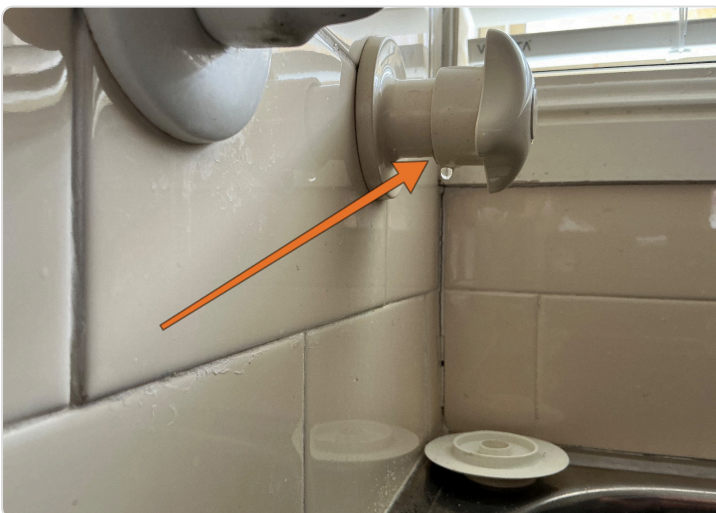
### 19. Tapware - Dripping

| # | Area | Room Type | Location | Defect Name | Recommendation |
|---|---|---|---|---|---|
| 19 | Interior | Laundry | | Tapware - Dripping | Engage a plumber to replace the washer or spindle to stop the drip. |

A tap is dripping in the open position in laundry

**Recommendation:** Engage a plumber to replace the washer or spindle to stop the drip.

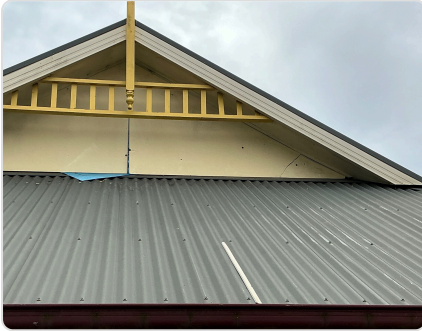
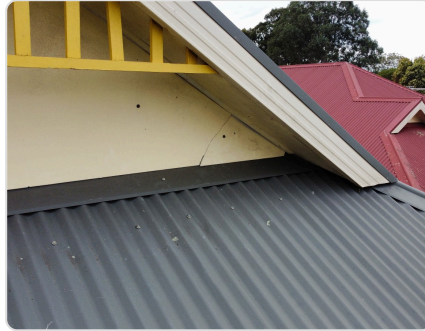
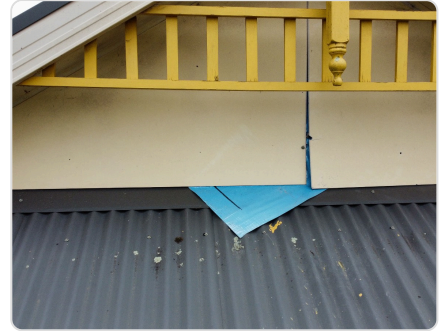
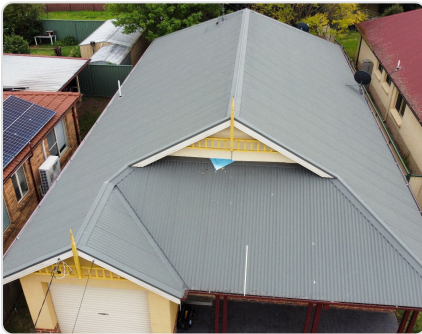
**20. Cladding - Delamination****MINOR**

| # | Area | Room Type | Location | Defect Name | Recommendation |
|---|---|---|---|---|---|
| 20 | Roof Exterior | | | Cladding - Delamination | Replace the delaminating cladding boards to match the existing. |

Some cladding boards are delaminating and losing integrity.

**Recommendation:** Replace the delaminating cladding boards to match the existing.
